# Clinical case

## SSV reflux with skin damage and healed ulcer in the medial malleolus

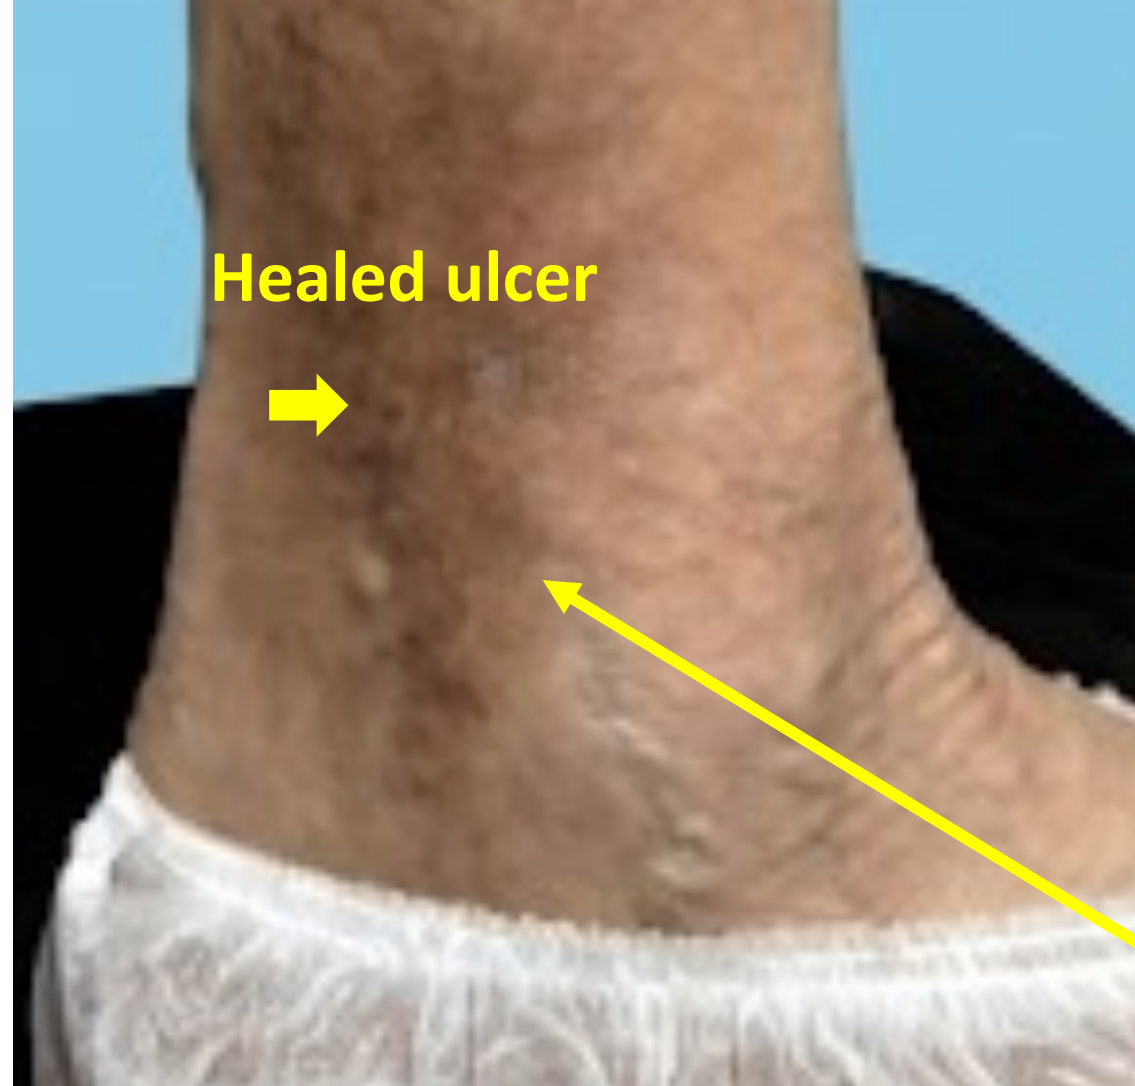
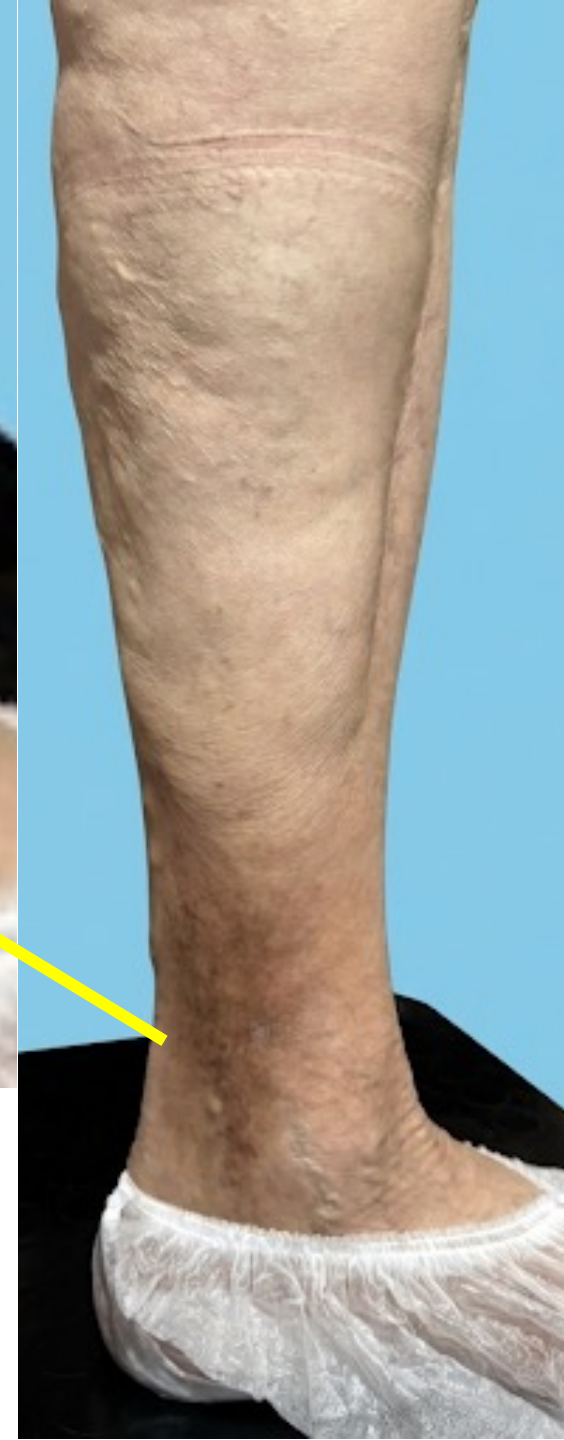
**Varicose vein in the area of skin damage.**

Edema of the left lower limb, with varicose veins and skin damage at the medial malleolus.

She developed an ulcer 1 year ago that was healed 2 months ago with local care and compression.

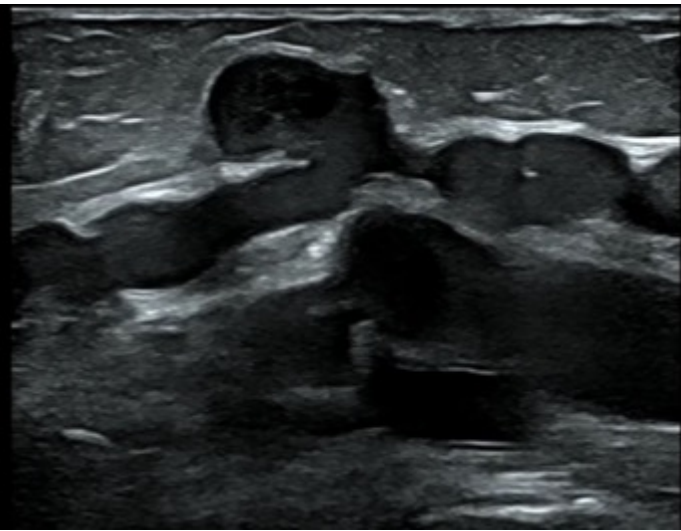
**SSV dilated tributary  
measuring 7.4mm**

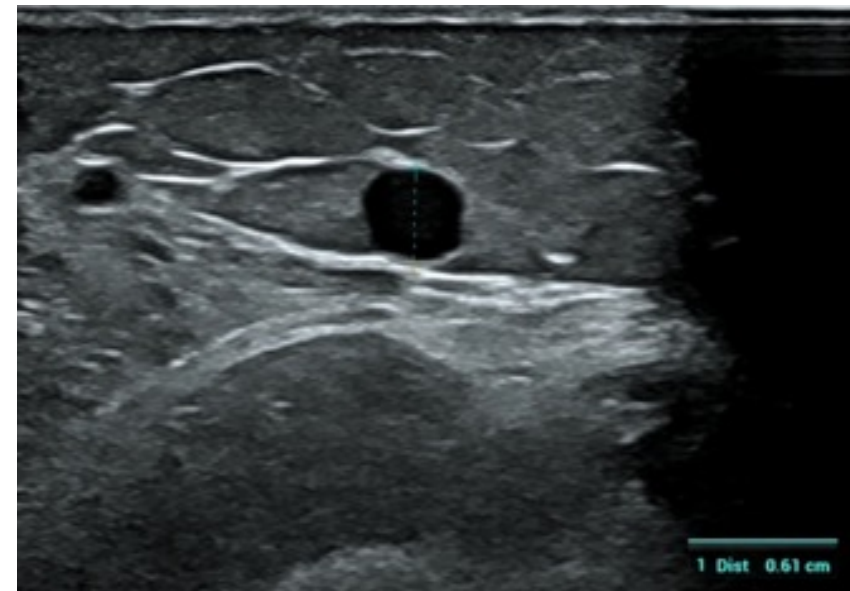
SSV at the mid calf measuring 6.1mm

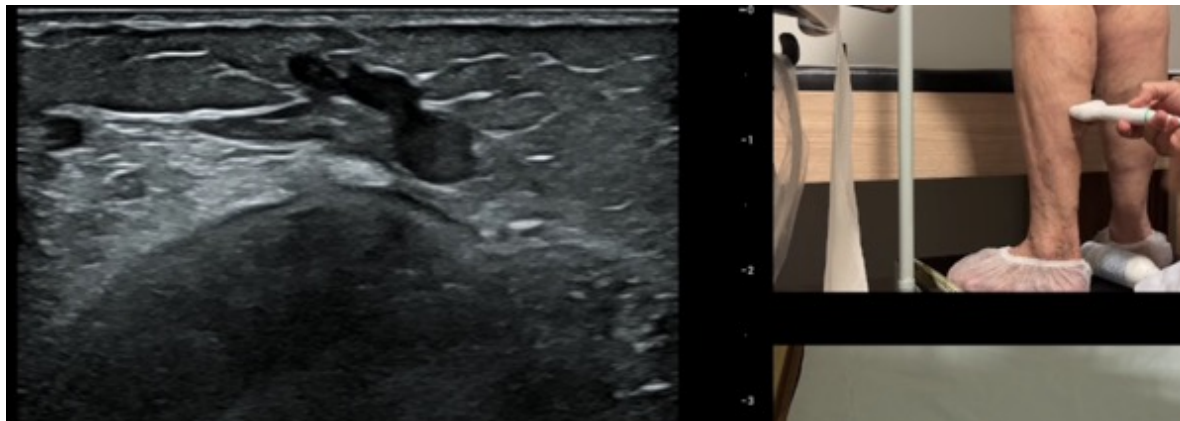
SSV tributary
